FOUNDATION SECTIONS

OPTIMUM PERSONAL CARE
1110 LAKEVIEW DRIVE
SUGAR LAND, TX. 77478

SHEET: S2

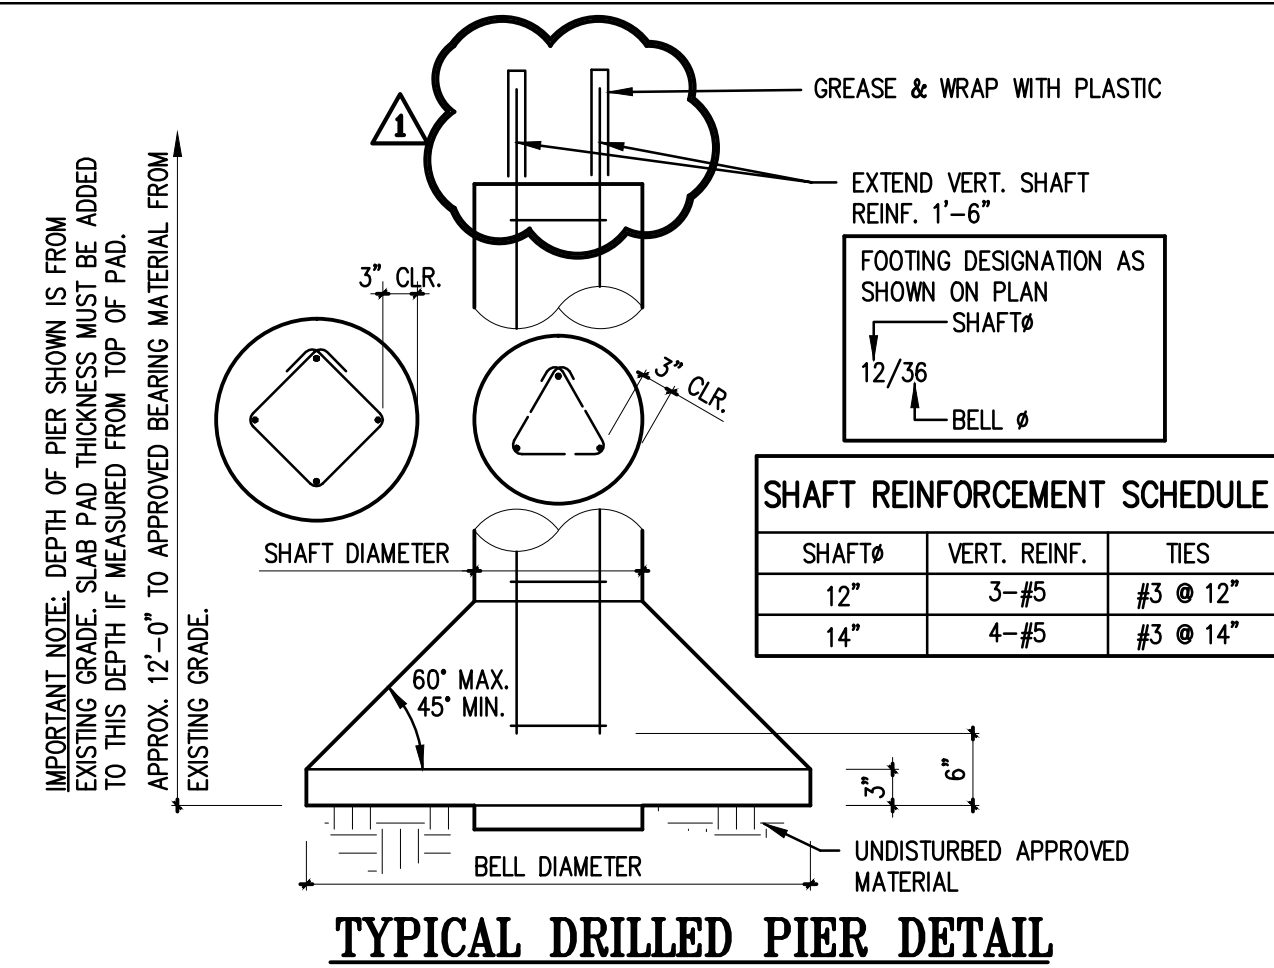
TYPICAL DRILLED PIER DETAIL

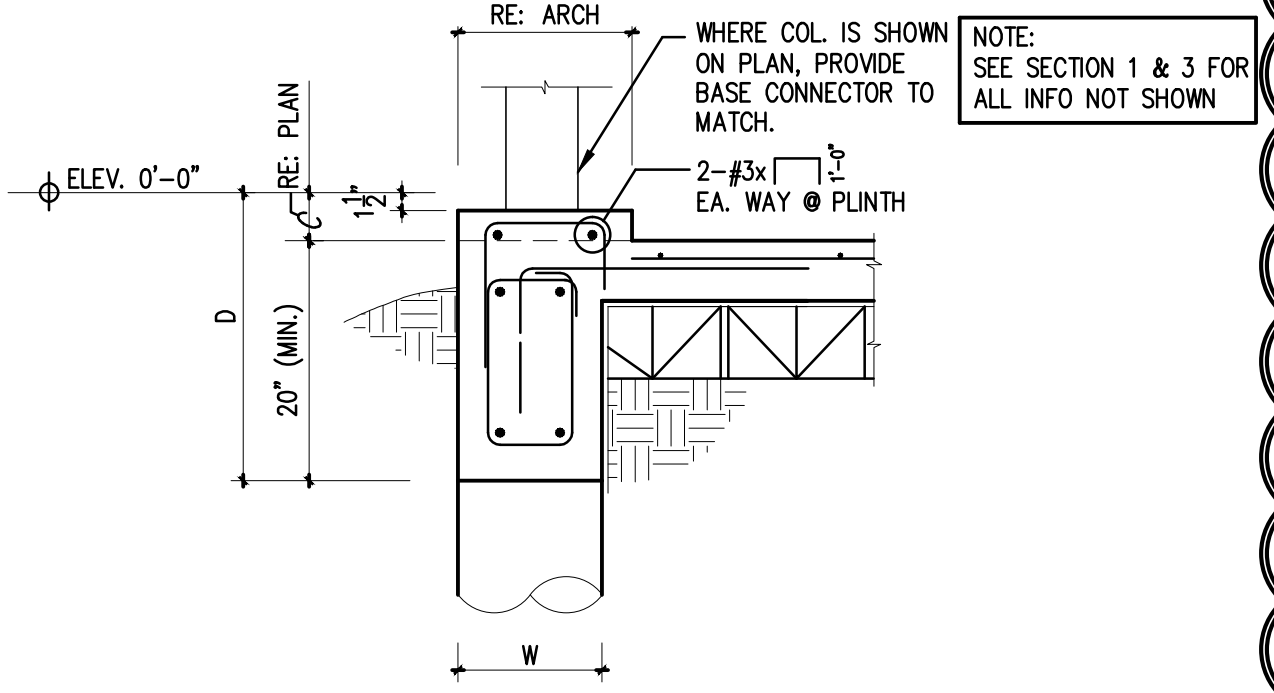
8 SECTION: TYPICAL GRADE BEAM @ PLINTH
